Effectiveness of Direct Restorative Materials in Repairing Cast Restorations

T J CARLSON • M A COCHRAN • M R LUND

Summary

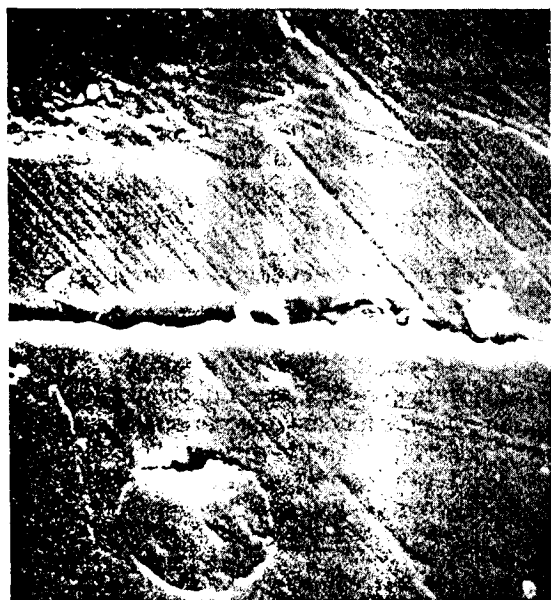
FIG 3. Typical gap formed between the casting (top) and resin.

of adaptation. Figure 3 shows a typical inlay/resin margin; Figure 4, inlay/amalgam; and Figure 5, inlay/direct gold. In all photographs, the cast gold is at the top and the repair material is toward the bottom. The direct gold repairs consistently showed a lack of any visible interface (Fig 5).

All of the margins between cast gold and resin demonstrated lack of bonding and all specimens exhibited a gap between the resin and the gold after thermocycling. As expected, the resin bonded with the etched enamel. This pattern would indicate that resin is not an acceptable repair material for cast restorations, since the lack of bonding and resultant open interface between the resin and gold would lead to microleakage and the likelihood of caries.
